MOTOCRANE RADICAL

MotoCrane RADICAL Troubleshooting Guide v4.0
JUN 2023

This guide helps users diagnose and repair issues in the field.
It should be used in conjunction with the RADICAL Operation Manual.

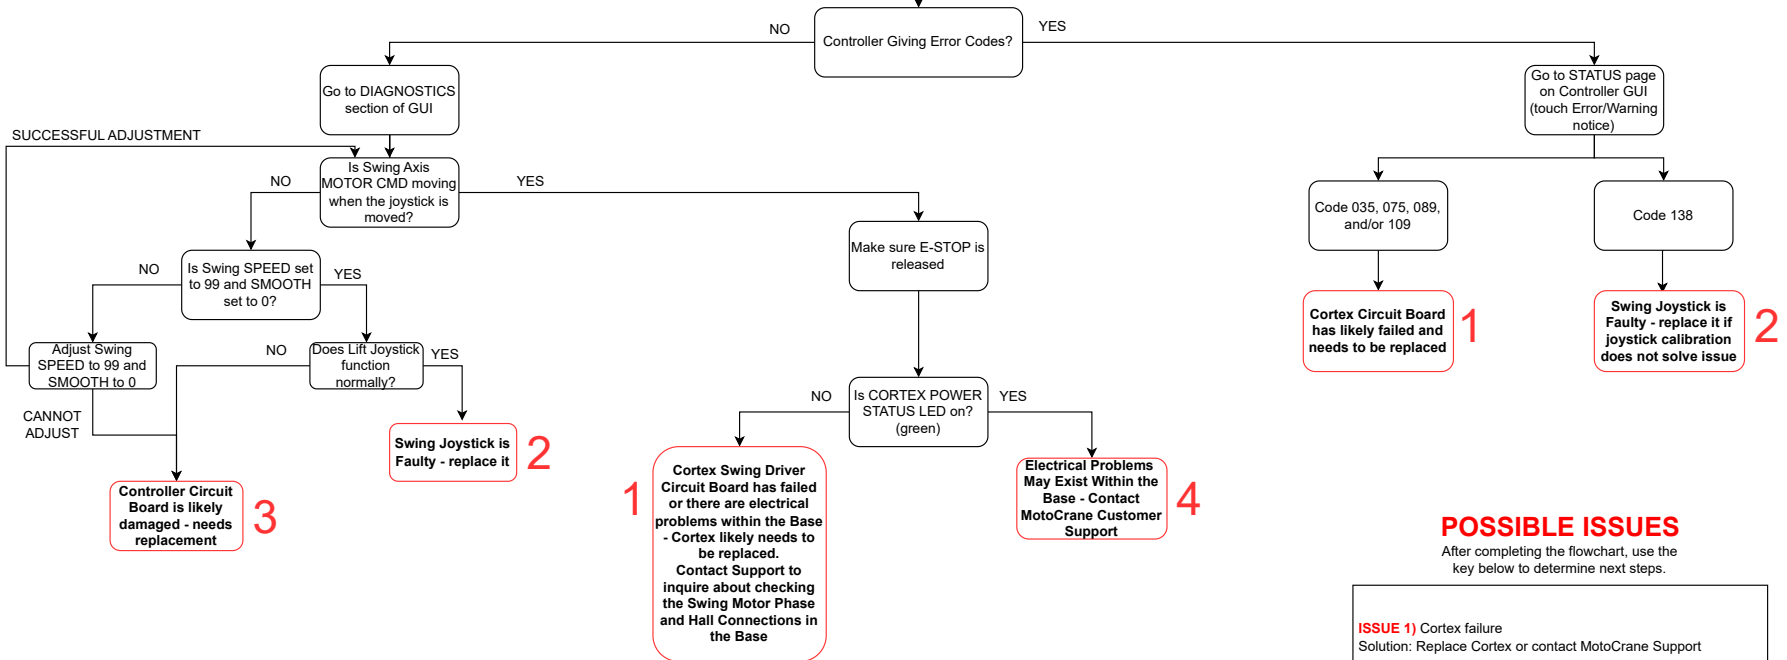
"SWING IS NOT WORKING"

*Assumes PSU Main Power ON/OFF Switch is already "ON"
 * Try different or new cables, if possible, before moving to troubleshooting steps

After completing the flowchart, use the key below to determine next steps.

- ISSUE 1** Cortex failure
Solution: Replace Cortex or contact MotoCrane Support
- ISSUE 2** Swing joystick failure
Solution: Replace joystick or contact MotoCrane Support
- ISSUE 3** Controller Board failure
Solution: Replace Controller board or contact MotoCrane Support
- ISSUE 4** RADICAL Base Electrical Issue
Solution: Contact MotoCrane Support

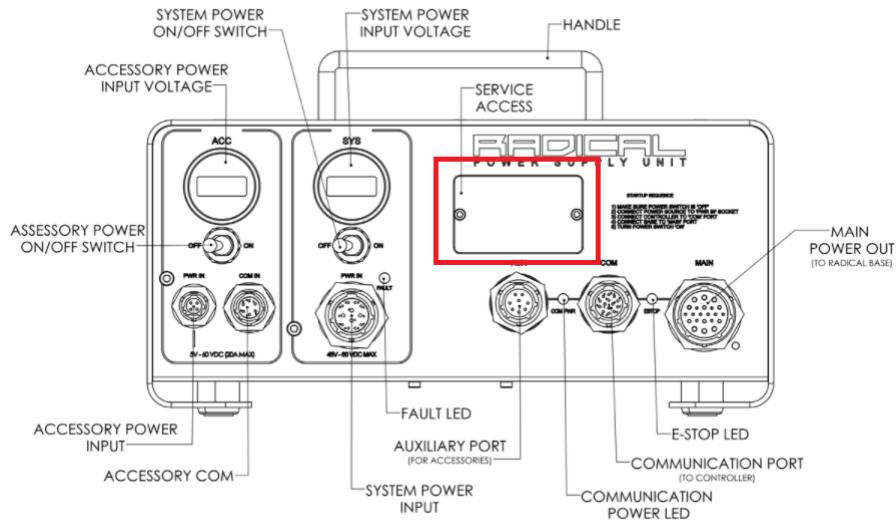
1. Make sure System Power is turned OFF
2. Remove the small access panel on the front face of the RADICAL PSU, using a 2.5mm hex key

3. Gently pull out the small snubber circuit PCB (wiggling slightly side to side if needed)
4. Remove the fuse from the back side of the PCB
5. Using a multimeter, check for continuity across the fuse
 - a. If there is continuity, the fuse is GOOD and can be replaced
 - b. If there is no continuity, the fuse is BAD and there is likely a problem with the snubber PCB - contact MotoCrane Support for determining a final diagnosis, and the steps for replacement or repair

The RADICAL PSU contains electronics that prevent dangerously high levels of voltage to the system. This is referred to as the "snubber" circuit. The snubber circuit bleeds this excess energy using a power resistor. In an abnormal situation, such as a system malfunction or applying too high of an input voltage, the snubber circuit may get damaged or the fuse may blow. To access and check the snubber circuit, follow these steps:

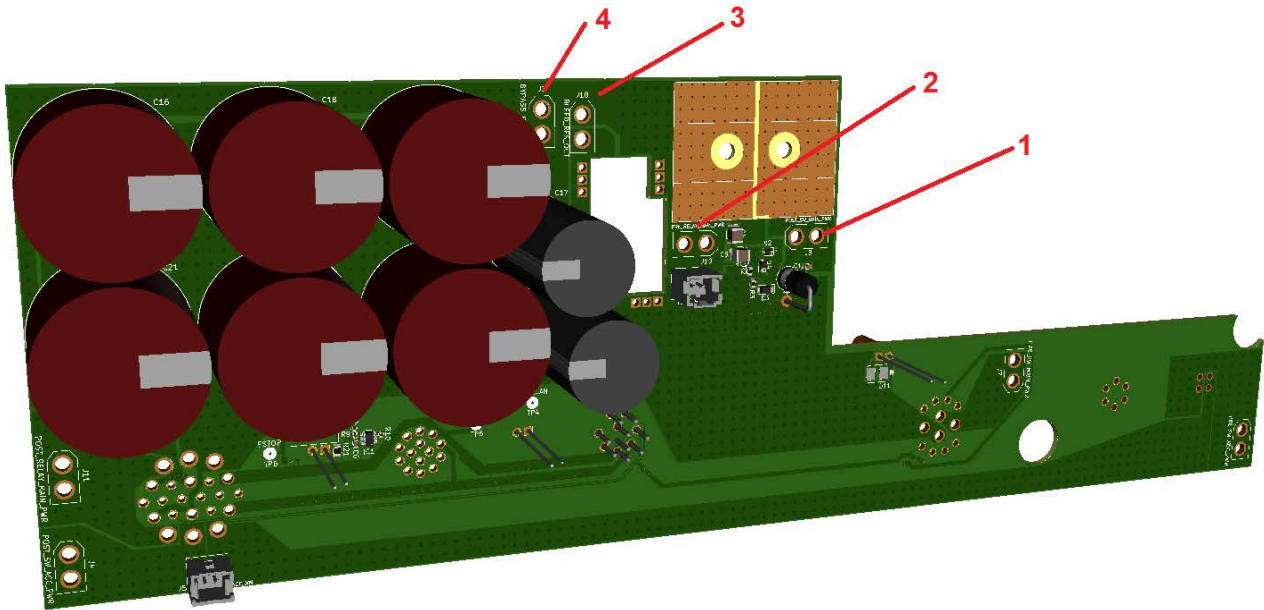
PSU Circuit Board Annotation for Reference (back side)

1. Remove the cover of the PSU module
 - a. Remove the rubber pads covering the bottom "feet"
 - b. Use a 2mm hex key to remove the 4 fasteners holding the "feet" together
 - c. Use a 2mm hex key to remove the 6 fasteners holding the top cover to the side panels
 - d. Carefully slide the top panel over the side panels and move it out of the way
2. Move the connector from J10 (item 2 in the annotation below) to J2 (item 4 in the annotation below)

3. Move the connector from J8 (item 1 in the annotation below) to J10 (item 2 in the annotation below)

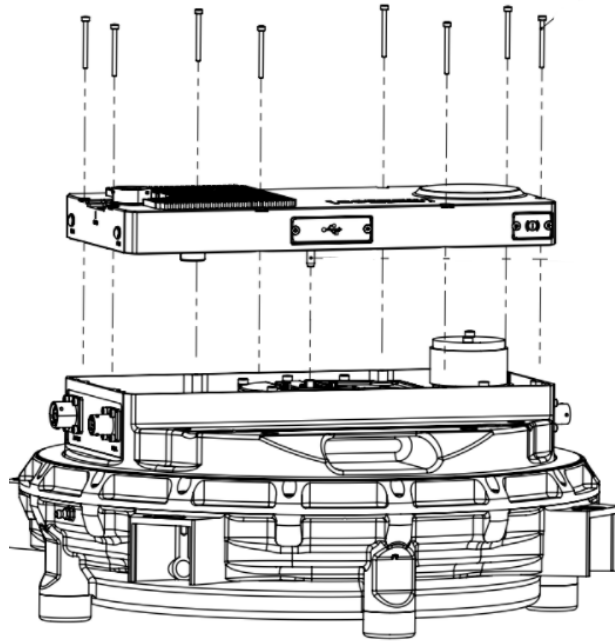
1. Remove the 8 M3 fasteners holding the Radical Cortex to the Base, using a 2.5mm hex key

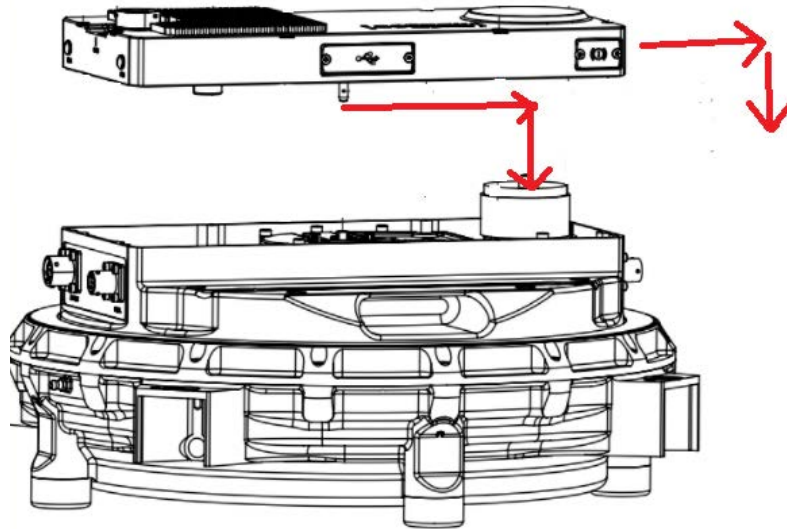
Steps 2,3,4

2. Carefully lift the Cortex up vertically, about 1 inch (25mm) - make sure the Swing encoder drive shaft is clear of the mating part that it slides into
3. Carefully move the cortex laterally, in the direction of the ACC PWR and ACC COM sockets
4. Rest the Swing encoder drive shaft in the center hole of the Swing brake (the shiny metal cylinder)

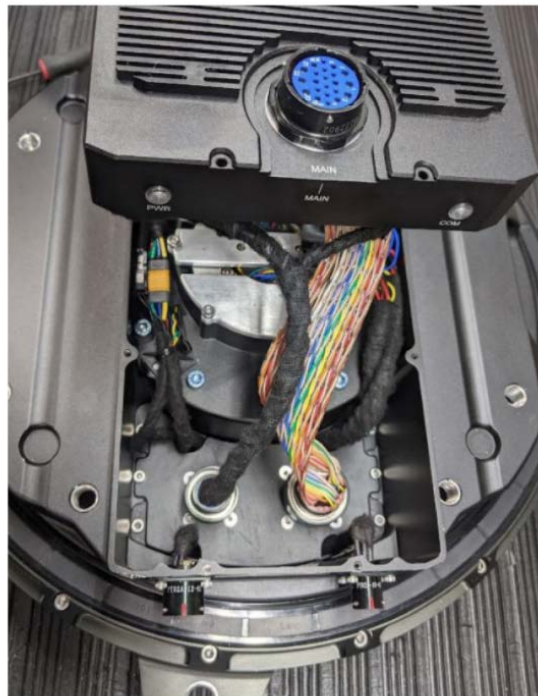
5. Unplug the two twist-lock connectors from the Cortex signal and power connector panel (inside the Base)(refer to below figure)

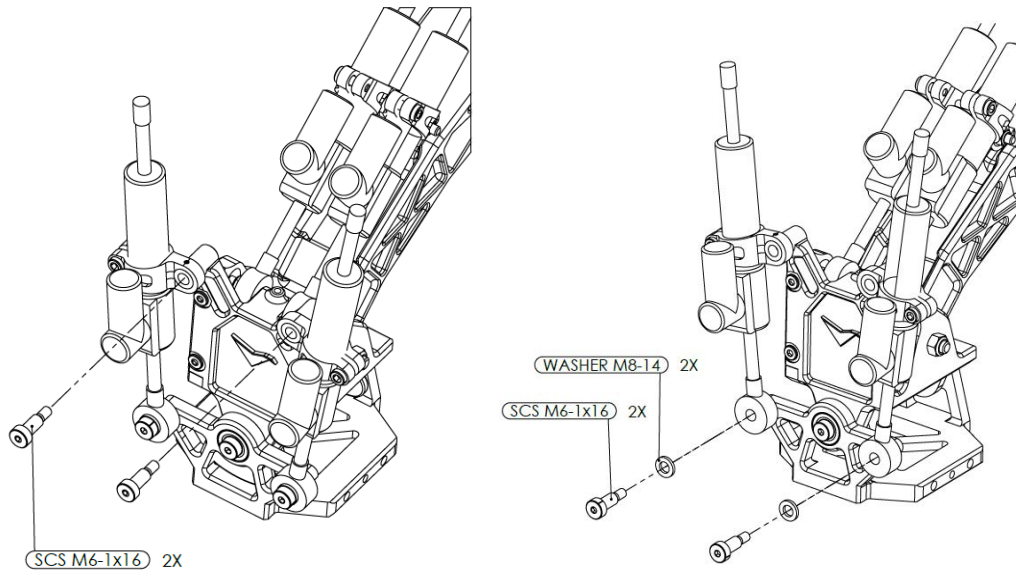
1. Remove the M6 shoulder bolts (Be cautious not to lose the shims when removing the shoulder bolts, keep the shims for shoulder bolt adjustment if needed)

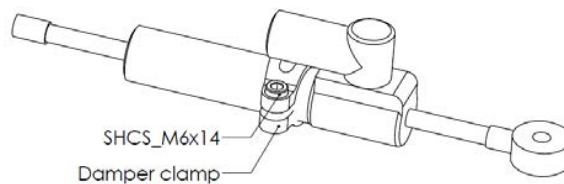
2. Remove the damper mount from the used damper and install it to the new damper. Keep the SHCS M6x14 loose for adjustment in step 5.

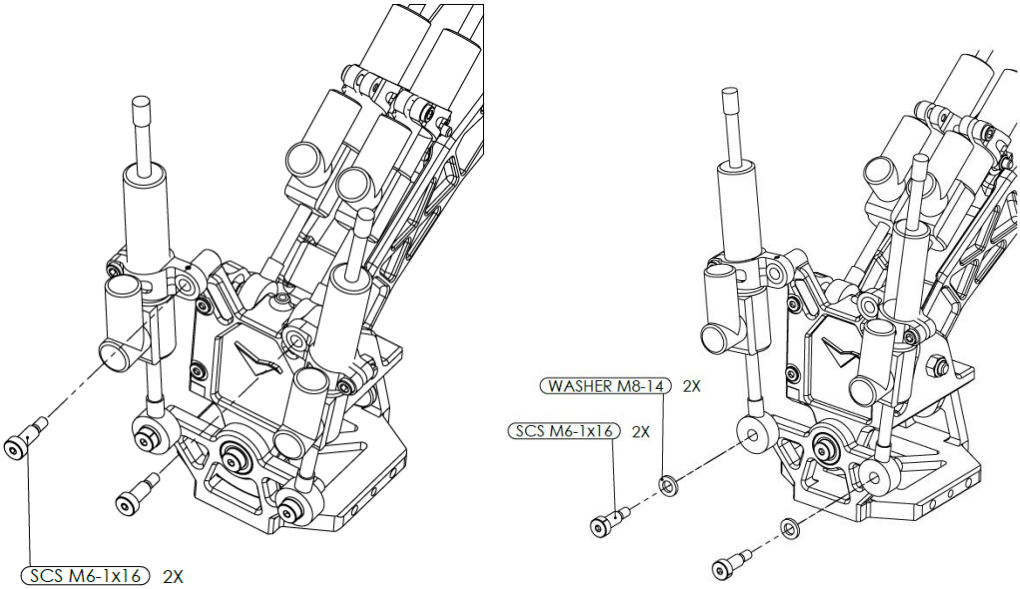
3. Install the new dampers to the Isolator as shown.

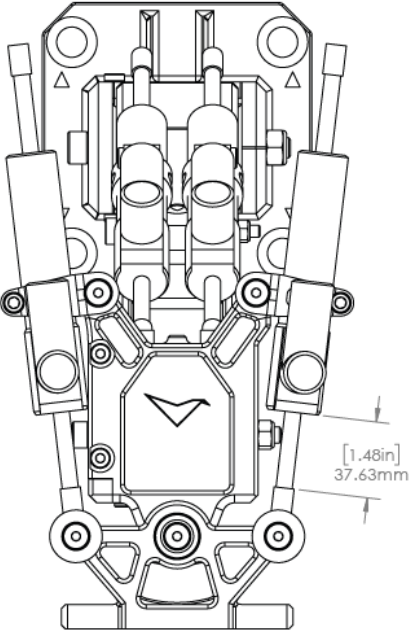
4. Adjust the dampers position by sliding the housing up or down. This step is to ensure the travel length is equal in both directions. Torque the SHCS M6x14 to specification once both dampers are adjusted.

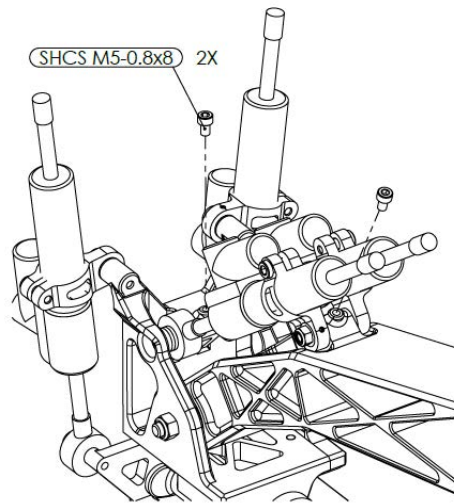
1. Remove SHCS M5x8 as shown.

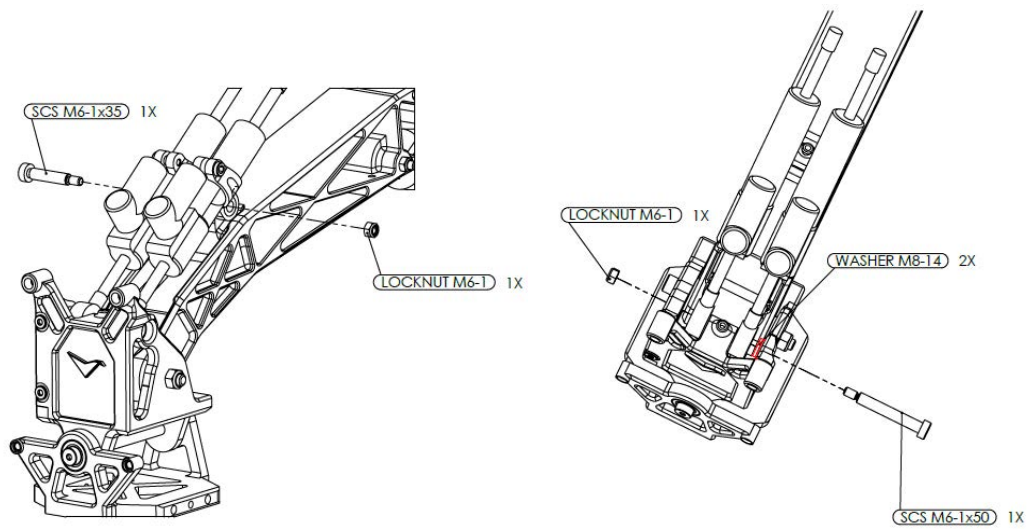
2. Remove the shoulder bolts from the isolator.

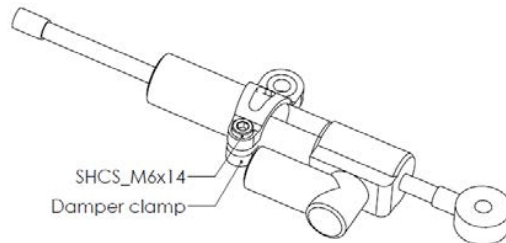
3. Remove the damper mount from the used damper and install it to the new damper. Keep the SHCS M6 loose for adjustment in step 6.

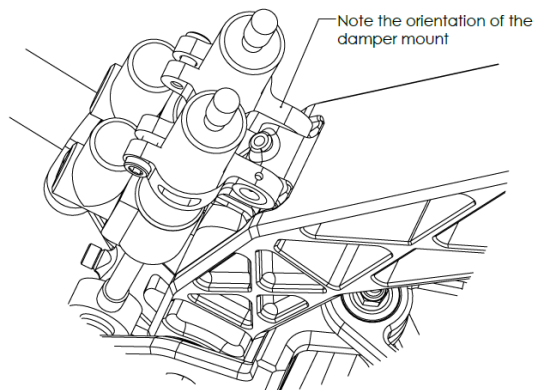
4. Check and make sure the damper clamps are installed correctly onto the dampers.

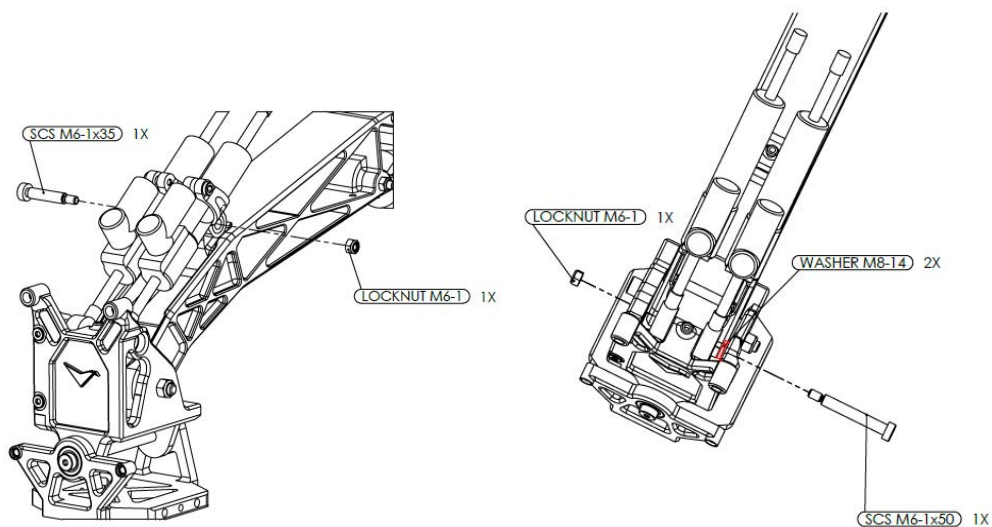
5. Secure the new dampers to the Isolator as shown.

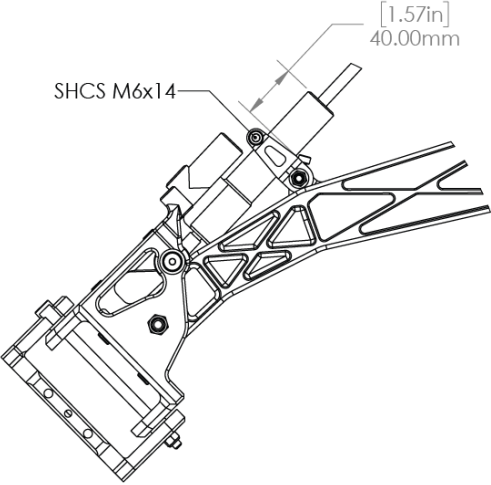
6. Adjust the dampers position by sliding the housing up or down. This step is to ensure the travel length is equal in both directions. Torque the SHCS M6x14 to specification once both dampers are adjusted.
